### RE: 2024 Sanitary Survey Report

## **SANITARY SURVEY REPORT**

**Entranosa Water Association  
NM3524626**

**RECORD OF INSPECTION**

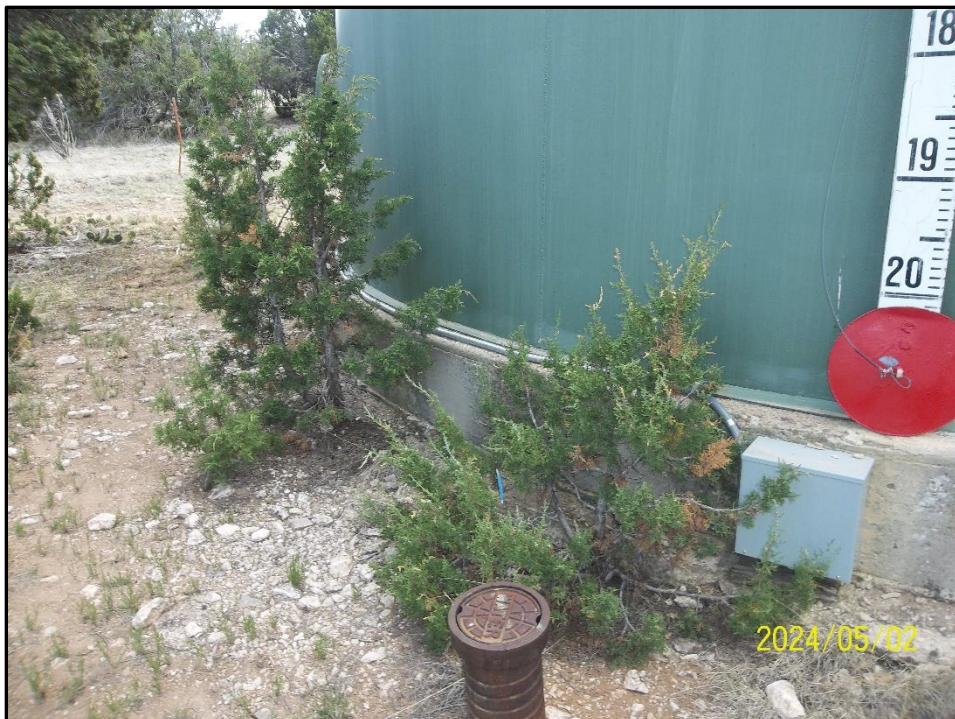
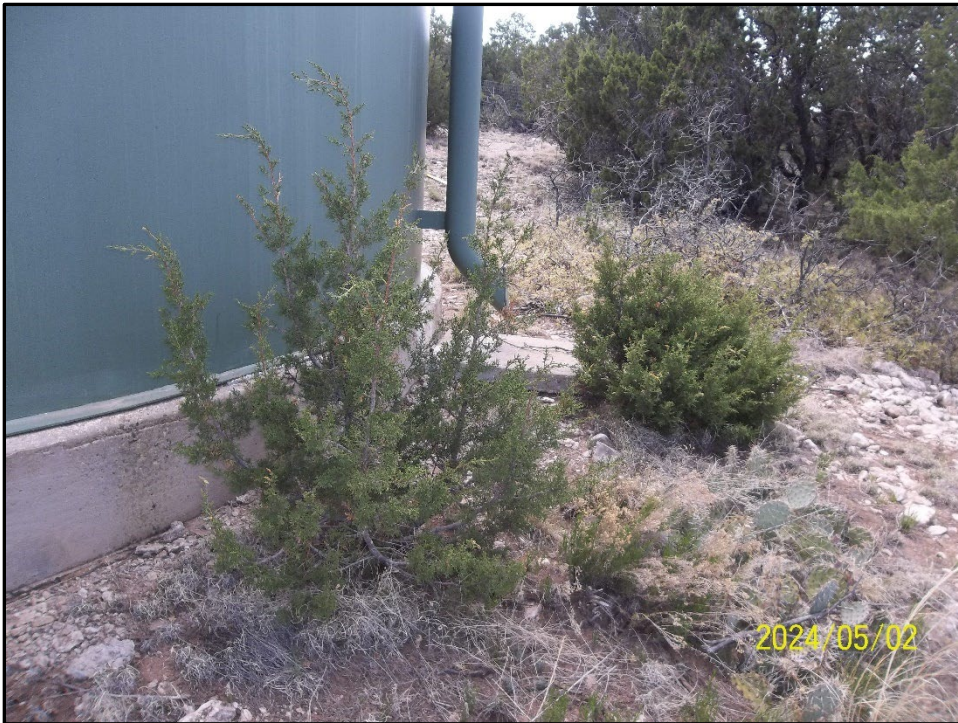
**Significant Deficiency Description:** The Hill Storage Tank (#24626012) has vegetation growing within close proximity to the tank foundation.

**Required Corrective Action:** The Entranosa Water Association must submit a photograph showing that the vegetation and small trees growing within 6 feet of the Hill Tank foundation have been removed.

**Note:** The vegetation in close proximity to the storage tank foundation was removed on May 30, 2024. No further action is required.

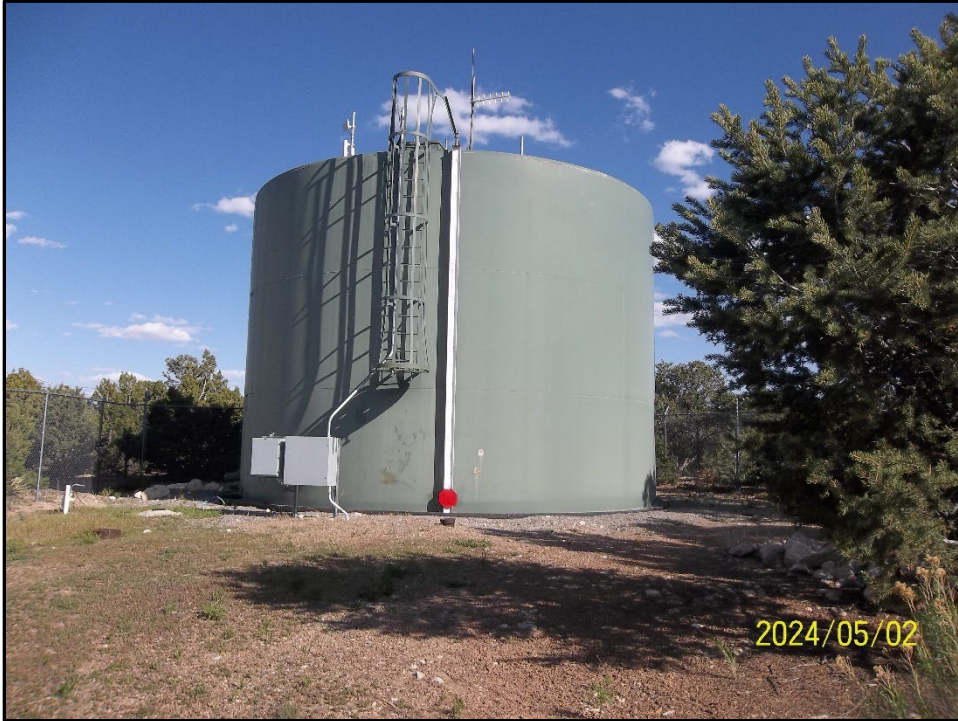
**Significant Deficiency Description:** The water level indicator for the Section 2 Tank (Los Leyendas) storage tank (#24626022) is broken.

**Required Corrective Action:** The Entranosa Water Association must submit a photograph to show that the water level indicator for the Section 2 Tank (Los Leyendas) storage tank (#24626022).

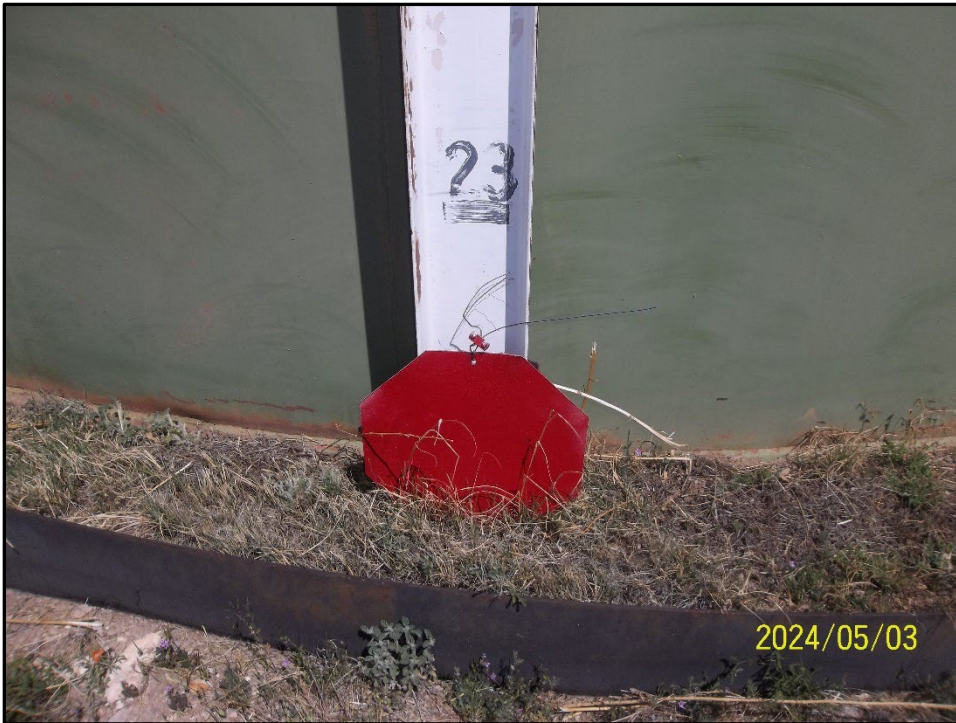
**Significant Deficiency Description:** The water level indicator on the Magic Valley Tank (#24626017) is broken.

**Required Corrective Action:** The Entranosa Water Association must submit a photograph to show that the water level indicator for the Magic Valley storage tank (#24626017) has been repaired.

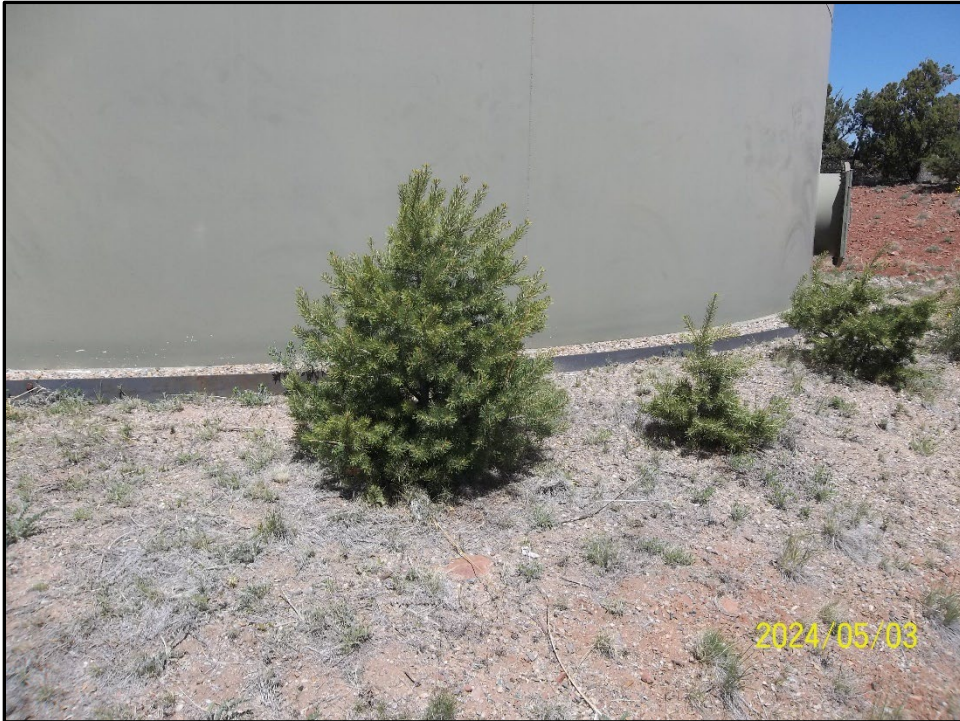
**Significant Deficiency Description:** The Paako Tank #2 Storage Tank (#24626026) has vegetation growing within close proximity to the tank foundation.

**Required Corrective Action:** The Entranosa Water Association must submit a photograph showing that the vegetation and small trees growing within 6 feet of the Paako Tank #2 ((#24626026) foundation have been removed.

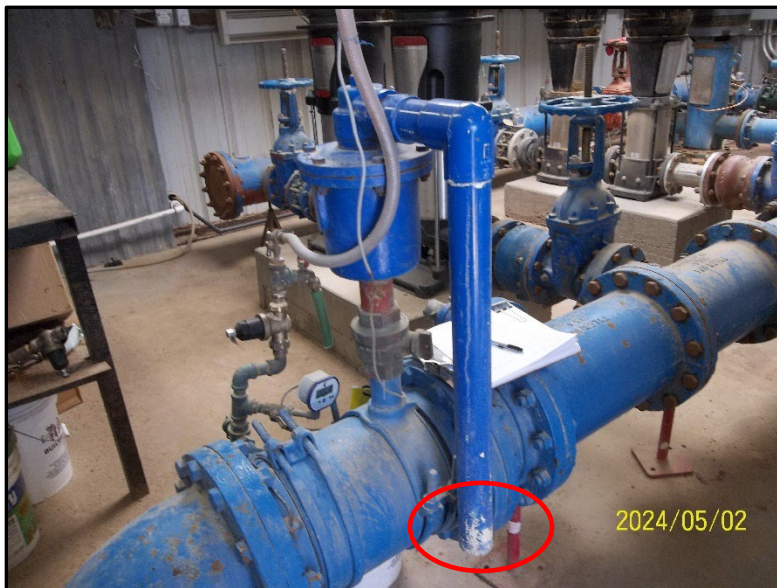
1. **Notes & Recommendations:** An air relief valve located on a booster pump manifold within the Nugent Pump Station (#24226002) was missing a fine mesh screen to prevent entry of insects or vermin.

**Recommended Action:** Place a 24-mesh corrosion resistant screen over the air relief blowdown pipe.

**Note:** The air relief blowdown was equipped with a screen on May 30, 2024. No further action is required.
