RE: 2018 Sanitary Survey Report

SANITARY SURVEY REPORT

Entranosa Water and Wastewater Coop NM3524626

RECORD OF INSPECTION

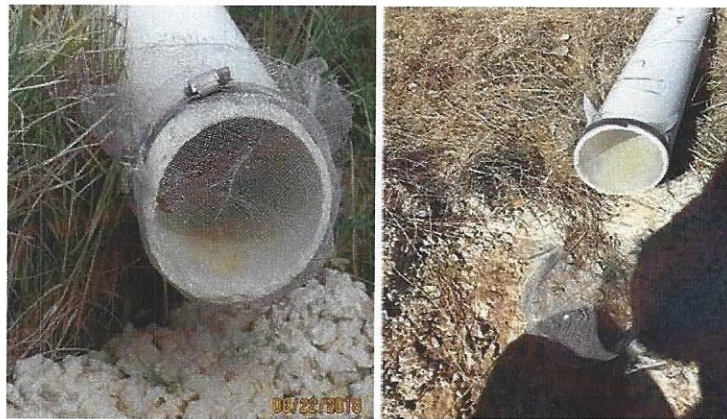
Corrected 2/14/2019

1. Deficiency: (001D) Screen on well blow-off pipe at Horton Well S-25 needs to be replaced

Concern/Description: Direct Contamination. Damage to appurtenances can result in the source being tampered with or damaged which can result in either contamination of the source or a water outage.

Corrective Action: Well blow-off pipe needs to be fitted with a corrosion-resistant 24 mesh screen. Entranosa Water and Wastewater Coop corrected deficiency on 2/14/2019.

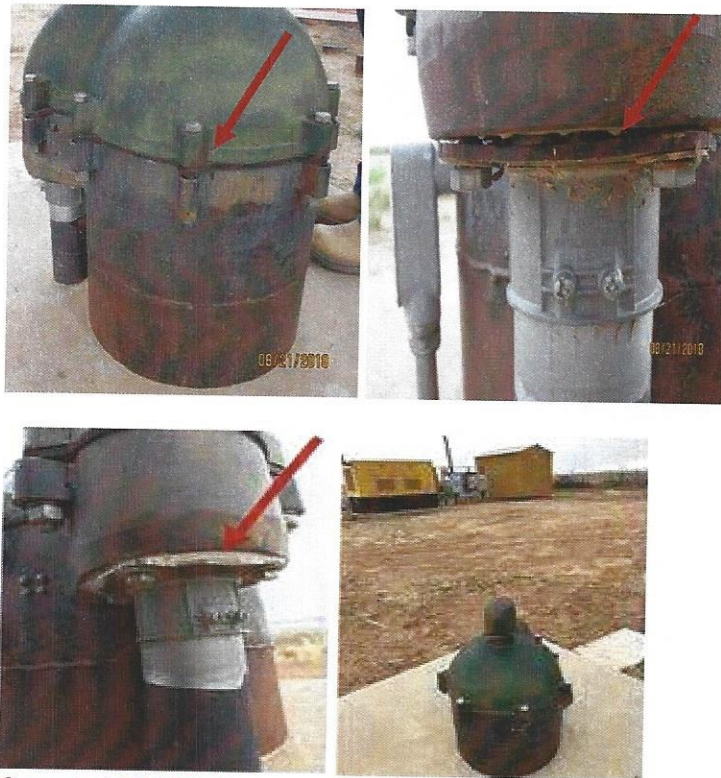
Corrected 2/14/2019

2. Deficiency: (001C) Pine Canyon Well #2 (South Pine), wellhead not secured from the elements

Concern/Description: Direct Contamination – Unauthorized access can result in water system being contaminated and key components being compromised which could result in a water outage.

Corrective Action: Bolts on well head are loose and wellhead needs to be sealed to prevent unauthorized entry and contamination. Entranosa Water and Wastewater Coop corrected deficiency on 2/14/2019.

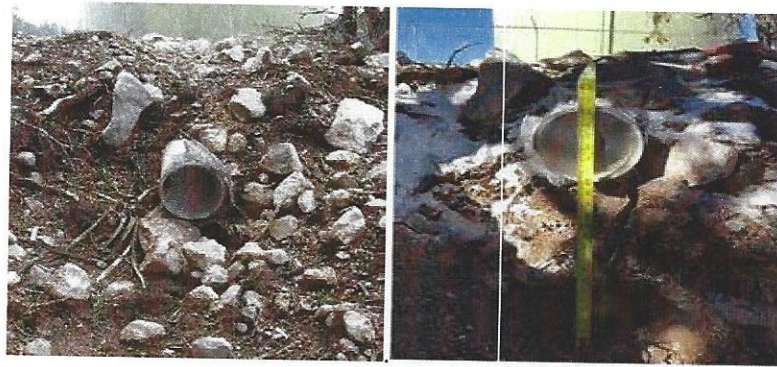
Corrected 2/14/2019

(0010) Crestview Tank #1 overflow pipe is not 12-18" above ground level

Concern/Description: Direct Contamination; Delivery; Operations Management – Missing or inadequately sized appurtenances can result in damage and contamination of the storage facility. Inability to drain or bypass the storage facility also limits the system's ability to inspect and maintain the storage facility. If a storage facility is not inspected and maintained, it may result in potential microbial growth or a failure of the structure.

Corrective Action: NMED/DWB recommends that the overflow pipe be excavated and extended so it ends 12"-18" above ground level. Entranosa Water and Wastewater Coop corrected deficiency on 2/14/2019.

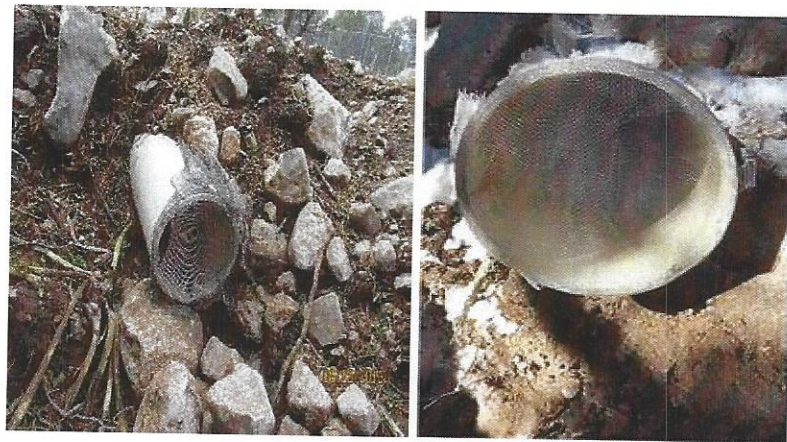
Corrected 2/14/2019

(001Q) Crestview Tank #1 has torn overflow screen.

Direct Contamination. Properly protected storage facilities prevent contaminated water, insects, vermin, or other potential contaminants from entering the facility.

Storage tank's overflow pipe screen should be replaced with a corrosion-resistant 24 mesh screen or be fitted with an acceptable flap valve. Entranosa Water and Wastewater Coop corrected deficiency on 2/14/2019.

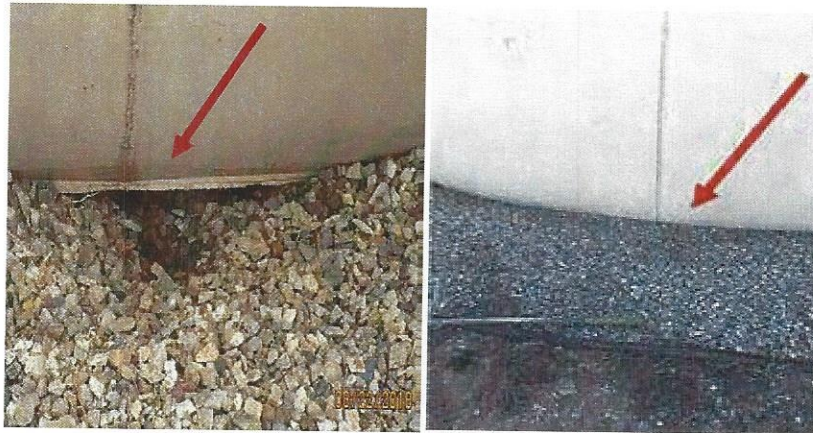
Corrected 2/14/2019

(001O) Ball Tank has vermin hole under tank

Direct Contamination; Delivery; Operations Management – Missing or inadequately sized appurtenances can result in damage and contamination of the storage facility. Inability to drain or bypass the storage facility also limits the system's ability to inspect and maintain the

storage facility. If a storage facility is not inspected and maintained, it may result in potential microbial growth or a failure of the structure.

Submit documentation to NMED-DWB showing hole under tank has been filled. Entranosa Water and Wastewater Coop corrected deficiency on 2/14/2019.

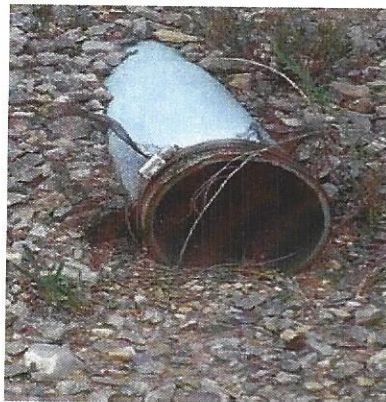
(0010) Steeplechase Tank #1 overflow pipe is not 12-18" above ground level

Direct Contamination – Missing or inadequately sized appurtenances can result in damage and contamination of the storage facility. Inability to drain or bypass the storage facility also limits the system's ability to inspect and maintain the storage facility. If a storage facility is not inspected and maintained, it may result in potential microbial growth or a failure of the structure.

NMED/DWB recommends that the overflow pipe be excavated and extended so it ends 12"-18" above ground level.

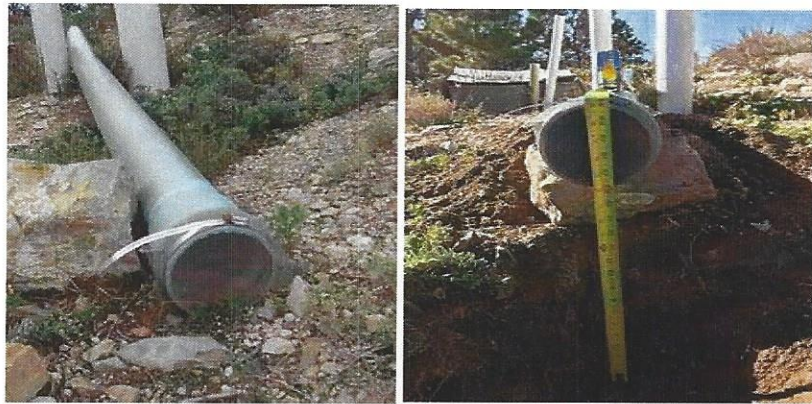
Corrected 2/14/2019

7. Deficiency: (0010) Magic Valley Tank overflow pipe is not 12-18" above ground level

Concern/Description: Direct Contamination – Missing or inadequately sized appurtenances can result in damage and contamination of the storage facility. Inability to drain or bypass the storage facility also limits the system's ability to inspect and maintain the storage facility. If a storage facility is not inspected and maintained, it may result in potential microbial growth or a failure of the structure.

Corrective Action: NMED/DWB recommends that the overflow pipe be excavated and extended so it ends 12"-18" above ground level. **Entranosa Water and Wastewater Coop corrected deficiency on 2/14/2019.**

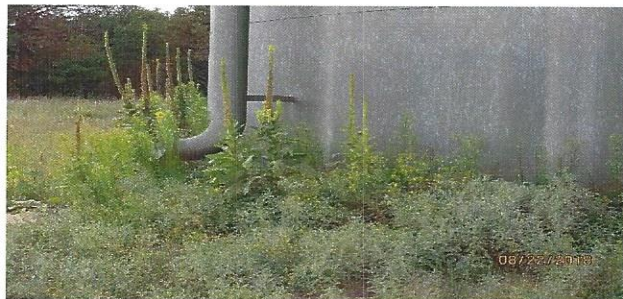
1. Deficiency: Poor housekeeping of Rancho Verde Tank foundation

Recommendation: It is recommended that the water system remove brush and weeds from around storage tank.
